The Malfunction Indicator Lamp (MIL) stays on or comes on after two seconds.

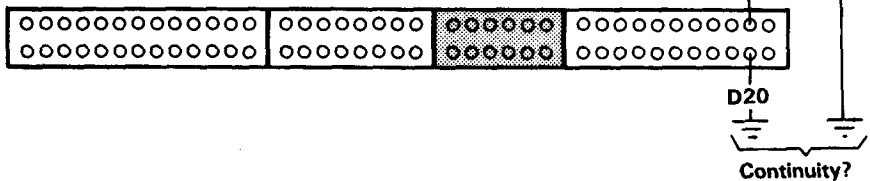
Connect the test harness. Disconnect the "D" connector from the ECM only, not the main wire harness (see page 11-37).

Check for continuity between body ground and D19, D20 terminals.

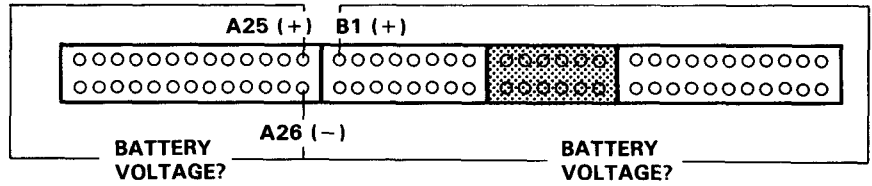
Measure voltage between A26 (-) and the following: B1 (+) and A25 (+).

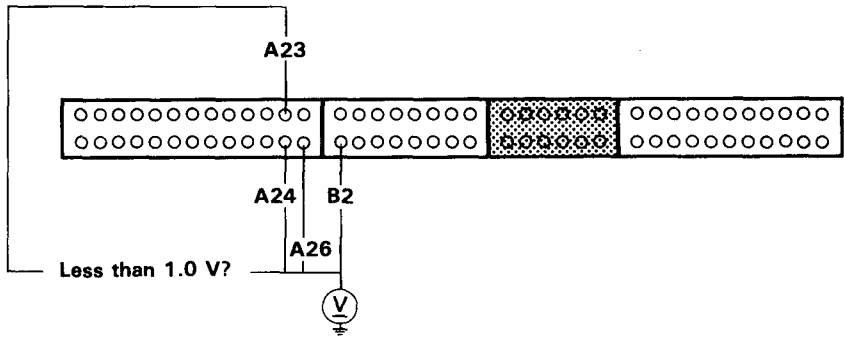
Measure voltage between body ground and the following terminals individually: A23, A24, A26, B2.

- Repair open in BLK wire between ECM (A23, A24) and G101 (located at thermostat housing).
- Repair open in BRN/BLK wire between ECM (A26, B2) and G101.
